# New Generation Runway Visual Range (RVR) Final Operational Test and Evaluation Report: Volume III

DOT/FAA/CT-TN95/32-III

This report will detail testing and results conducted on the New Generation Runway Visual Range (RVR) Visibility Sensor (VS) at the Cold Regions Research and Engineering Laboratories (CRREL). Extensive testing was performed on the sensor over a six week period from July 1993 to August 1993. Comments and conclusions for each test as well as ACW-200B recommendations and conclusions are detailed within the remainder of the report.

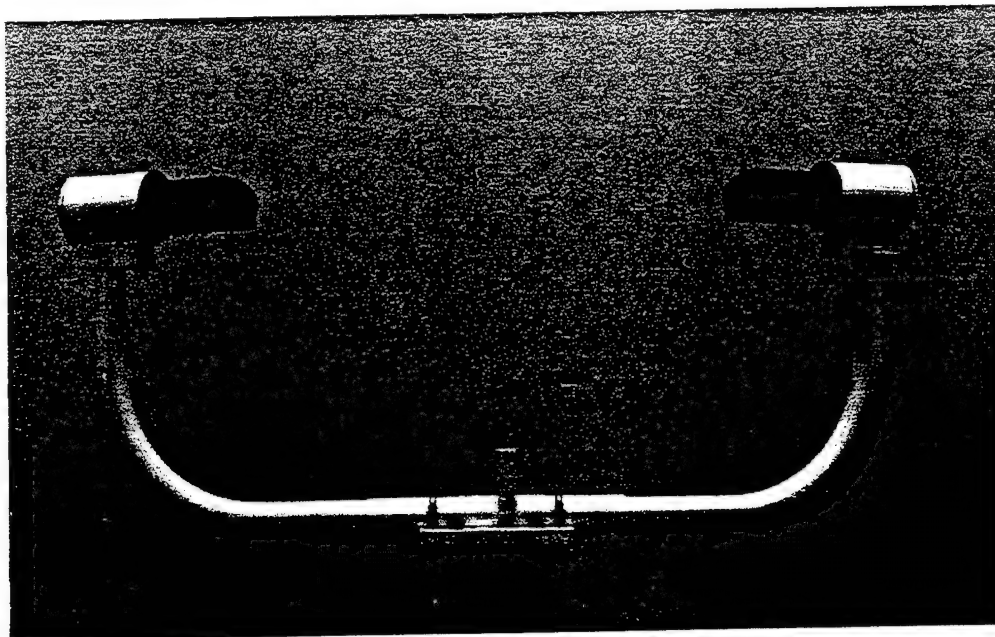
PHOTO 1. LOOK-OUT VISIBILITY SENSOR

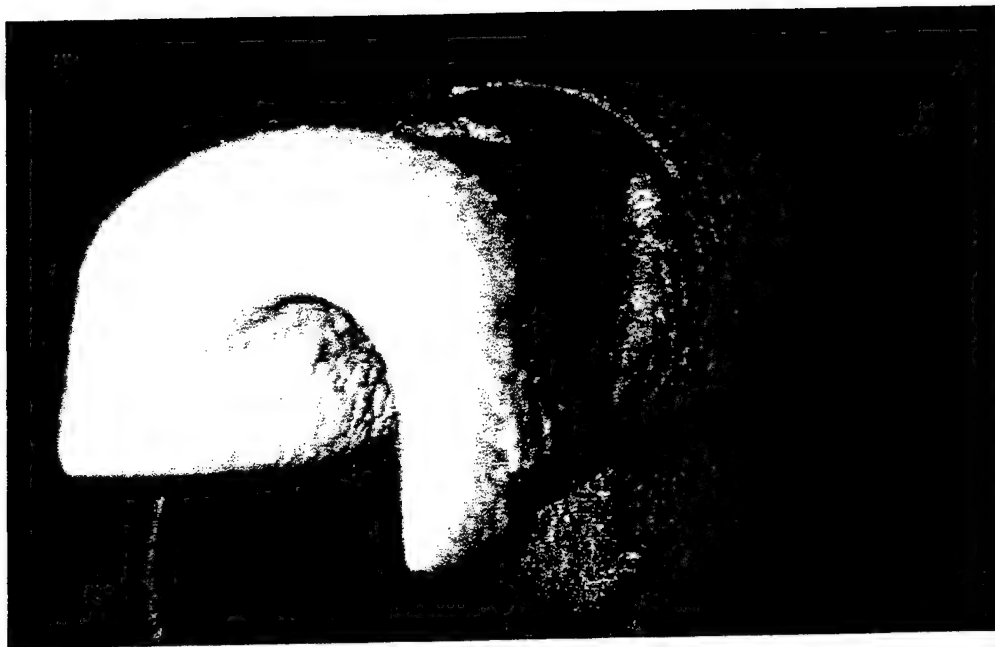
PHOTO 2. VISIBILITY SENSOR SNOW CLOGGING

It was noted during the events, that snow accumulated on unheated areas on the underside of the sensor hood (e.g., ref. photo 2). Additionally, snow clogging occurred on the sensor window. Because the sensor uses forward scatter technology, light impediments (e.g. VS clogging) to the scatter volume can result in higher than actual RVR readings.

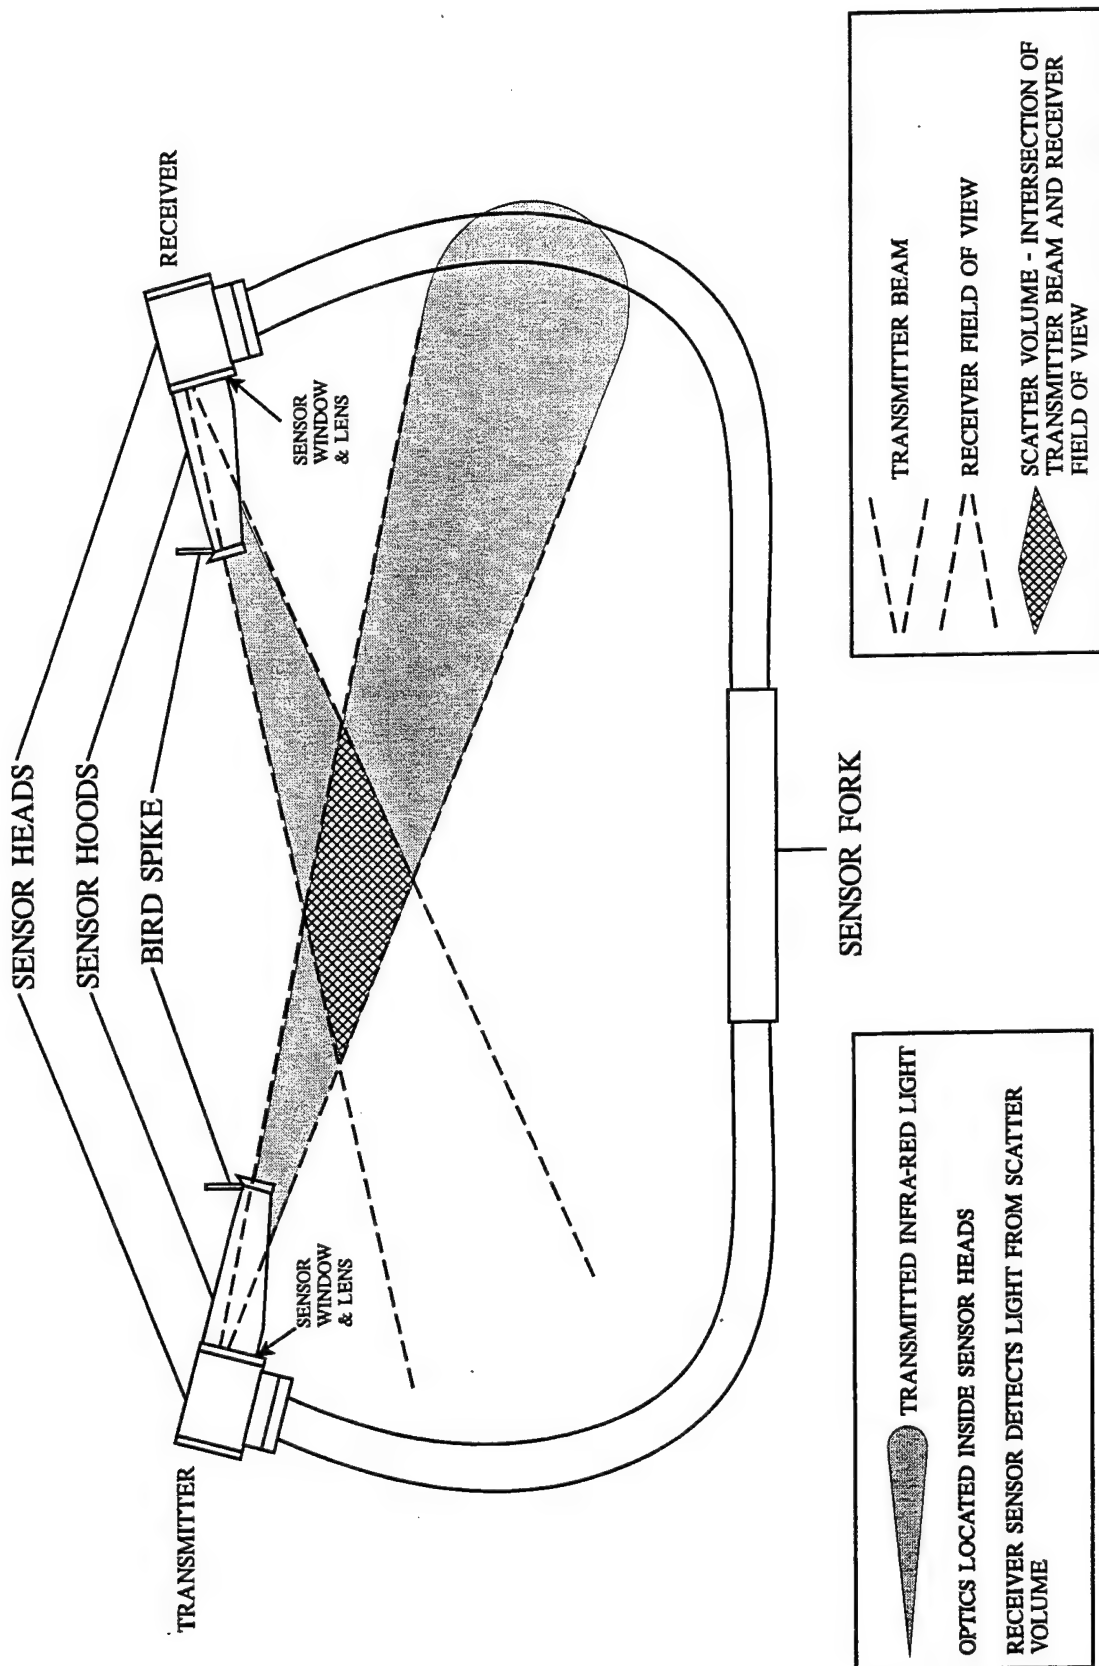
Figure 1. Look-Down Visibility Sensor Components

- VS (2). One look-down and one look-out configuration; Installed inside chamber laboratory;
- ALS (1). Installed inside chamber laboratory;
- Data Processing Unit (1). Installed outside chamber laboratory; and
- Sensor Interface Electronics (SIE) Enclosure (3). Installed inside chamber laboratory;

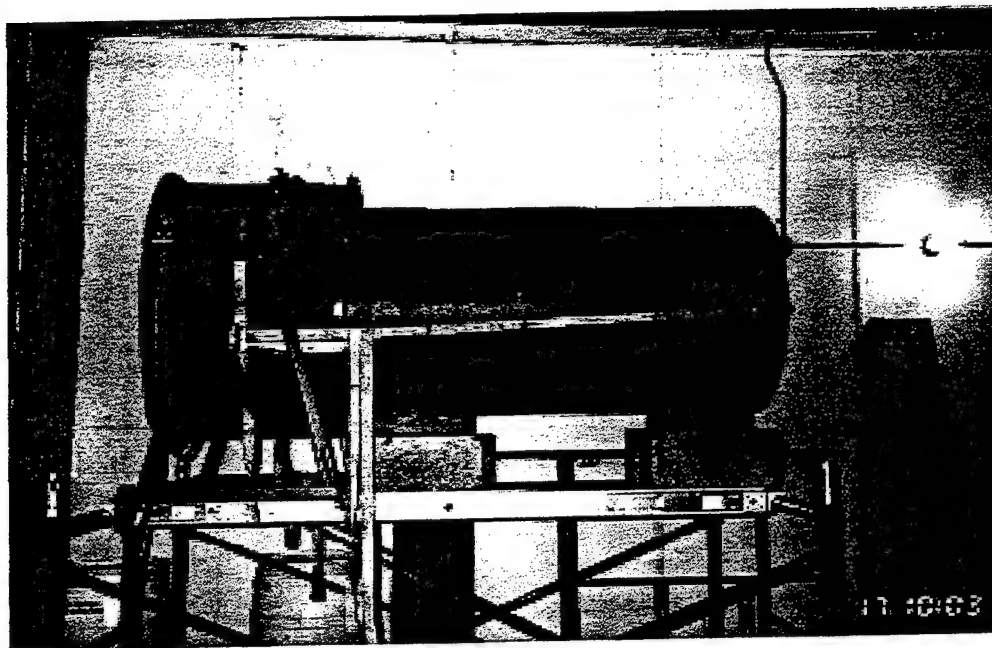
PHOTO 3. CYLINDRICAL WIND TUNNEL

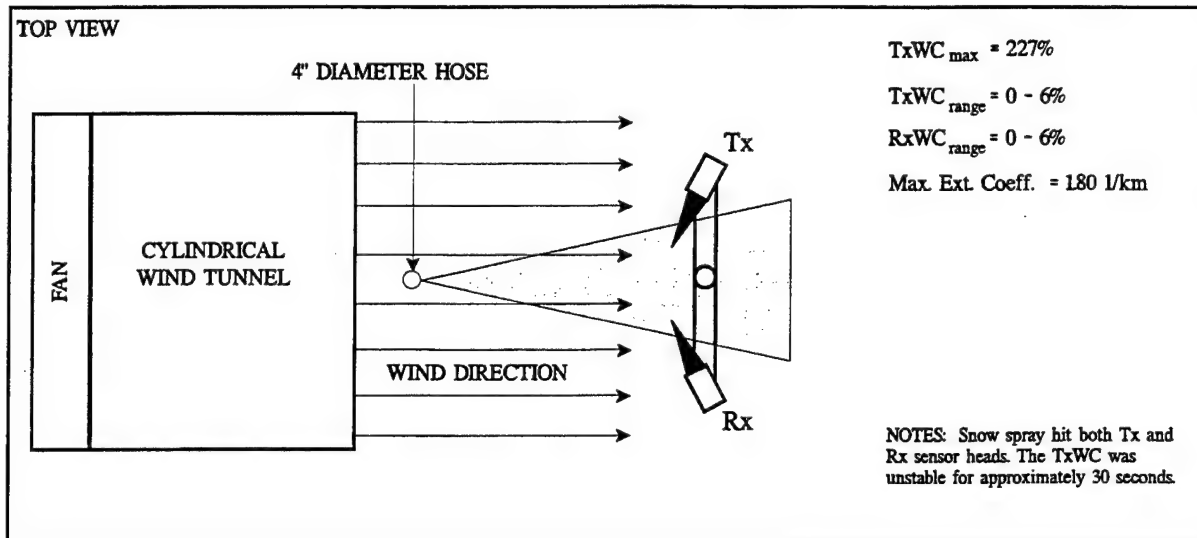
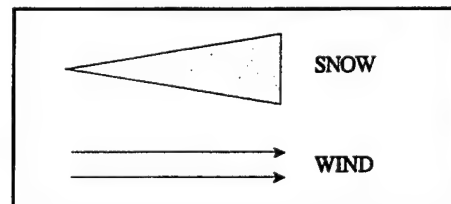
$WC_{max}$  = Maximum window contamination observed  
 $WC_{range}$  = Window contamination was in this range during 90% of the test time  
 Max. Ext. Coeff. = Highest extinction coefficient observed during the test  
 Snow Rate: 48 oz. per minute  
 Room Temp Test 1 =  $-7.46^{\circ} F$   
 Wind Speed = 20-22 mph  
 NOTE: All window contaminations are in 5% units

Figure 2. LKDOWN VS Volume Density Test 1 - Location: ROWPU Chamber

The maximum extinction coefficient achieved during testing was  $1.8 \text{ km}^{-1}$ . Since typical snow events have extinction coefficients ranging from 10 to  $20 \text{ km}^{-1}$ , this snow rate was not considered as representative of actual conditions.

In addition, it was noted that the volume of snow directed from the wind tunnel was large enough to hit the transmitter and receiver of the sensor. Because the purpose of this test was to establish volume density benchmarks for subsequent tests and not actually evaluate sensor performance, this was not desirable.

Although most of the transmitter and receiver window signals were small (i.e., fluctuating between 0% and 6%) large window signal fluctuations in excess of 200% were noted in the transmitter for approximately 30 seconds. This result suggests that the sensitivity of the transmitter may need to be reduced.

The snow volume was chunky and was propelled in spurts rather than in a consistent stream. More snow hit the transmitter and receiver components of the sensor than was anticipated. The design of the wind tunnel was determined to be the cause of these problems. Due to all of the aforementioned problems, the baseline determination from this test was not considered reliable.

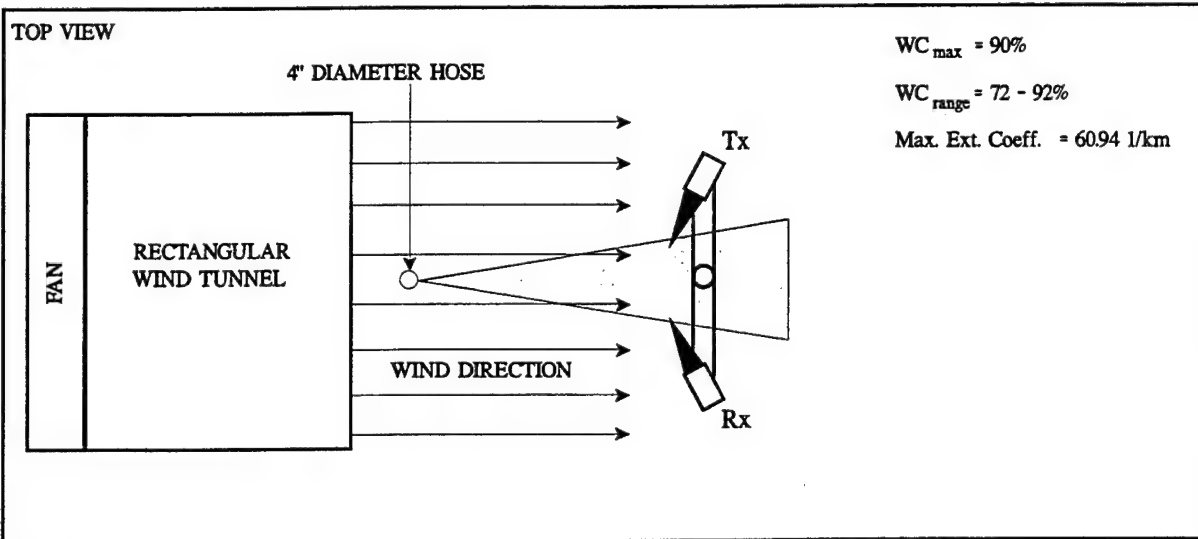
Figure 3. LKDWN VS Volume Density Test 2 - Location: ROWPU Chamber

Despite the fact that less snow was observed striking sensor components, high transmitter and receiver window signals were still noted with maximum readings between 72% and 92%. Nevertheless, these readings were significantly less than in the previous test.

- Chamber temperature of 20° F;
- Wind tunnel air speed measured at 20 mph; and
- Snow input rate of 48 oz. per minute.

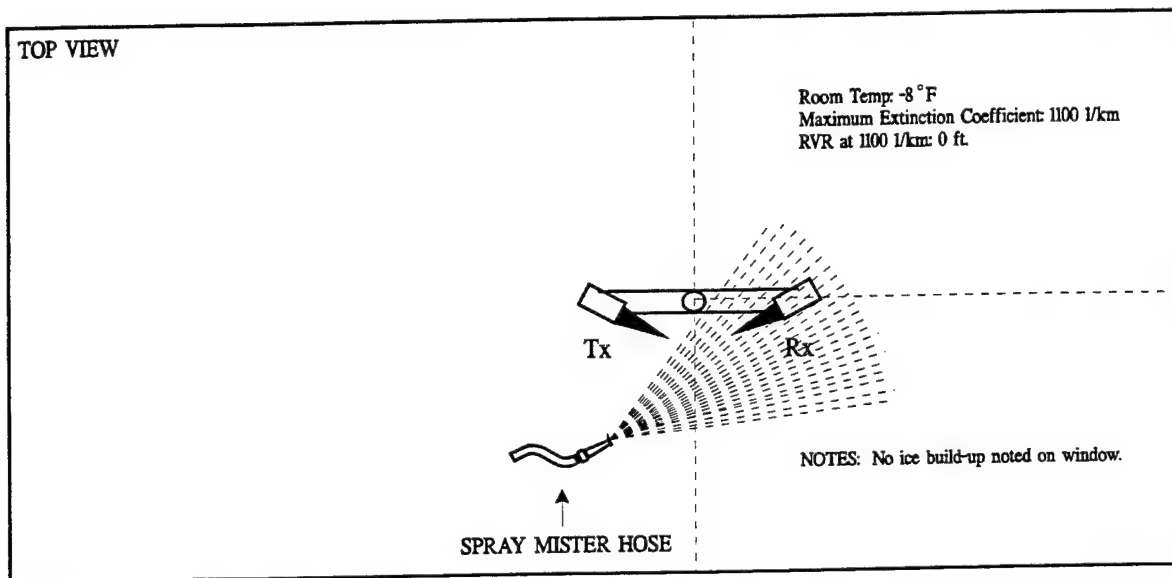
Figure 5. Spray Mist Test - Location: ROWPU Chamber

Spray Mist Test 1 was conducted on the Look-Down VS receiver on August 5, 1993 in the Navy Chamber. The intent of this test was to observe sensor performance during mist conditions for an extended period of approximately one hour. The test equipment was set up as shown in figure 5. The chamber temperature was  $-8^\circ \text{F}$  at the start of the test.

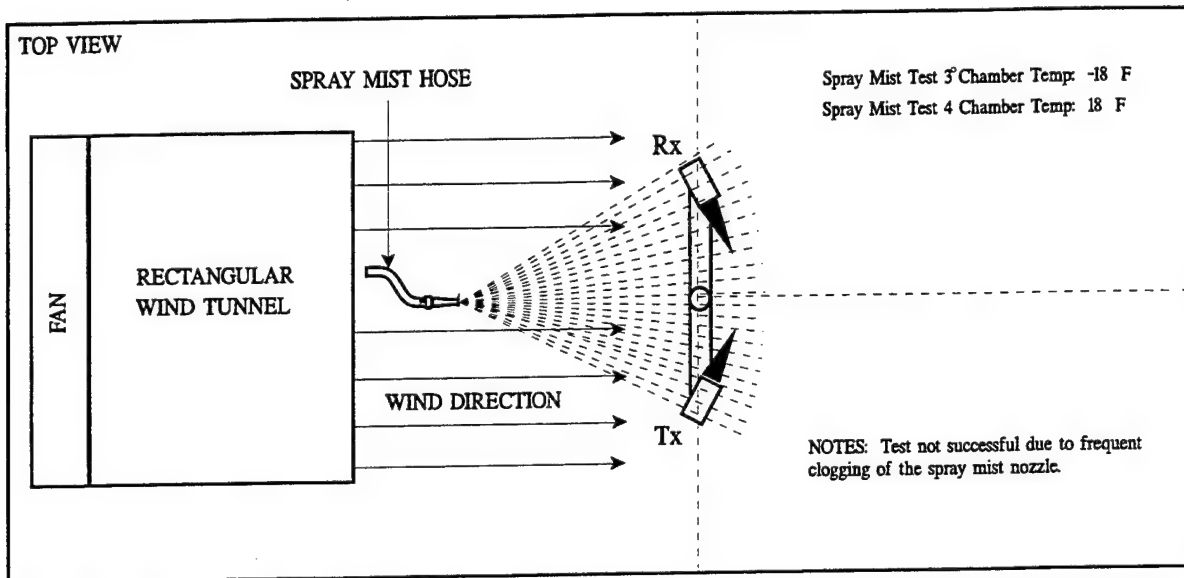
Figure 6. Spray Mist Test - Location: ROWPU Chamber

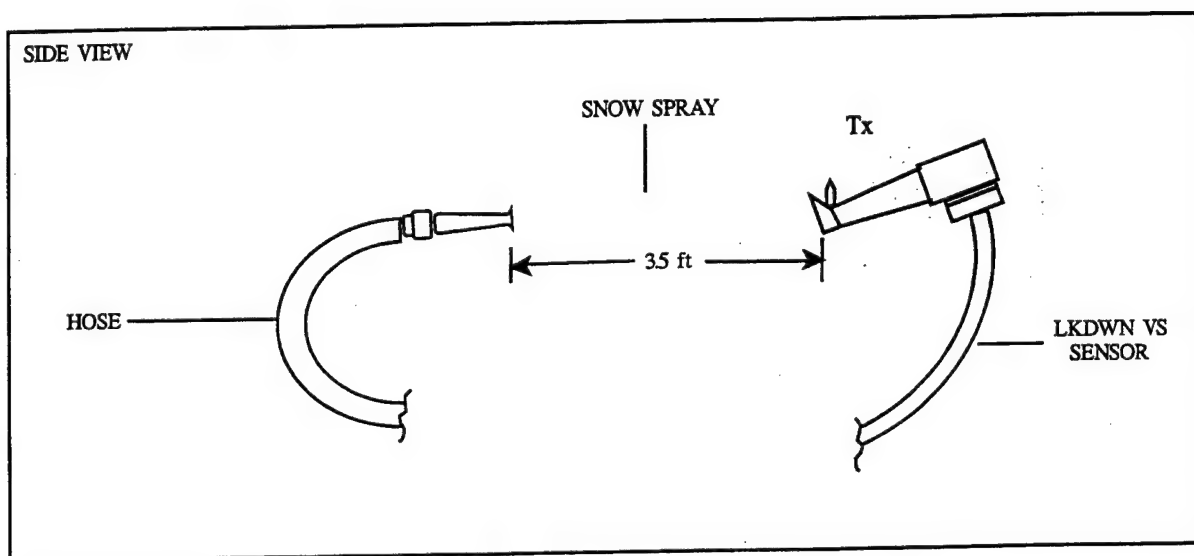
Figure 7. Horizontal Blowing Snow Test - Location: Navy Chamber

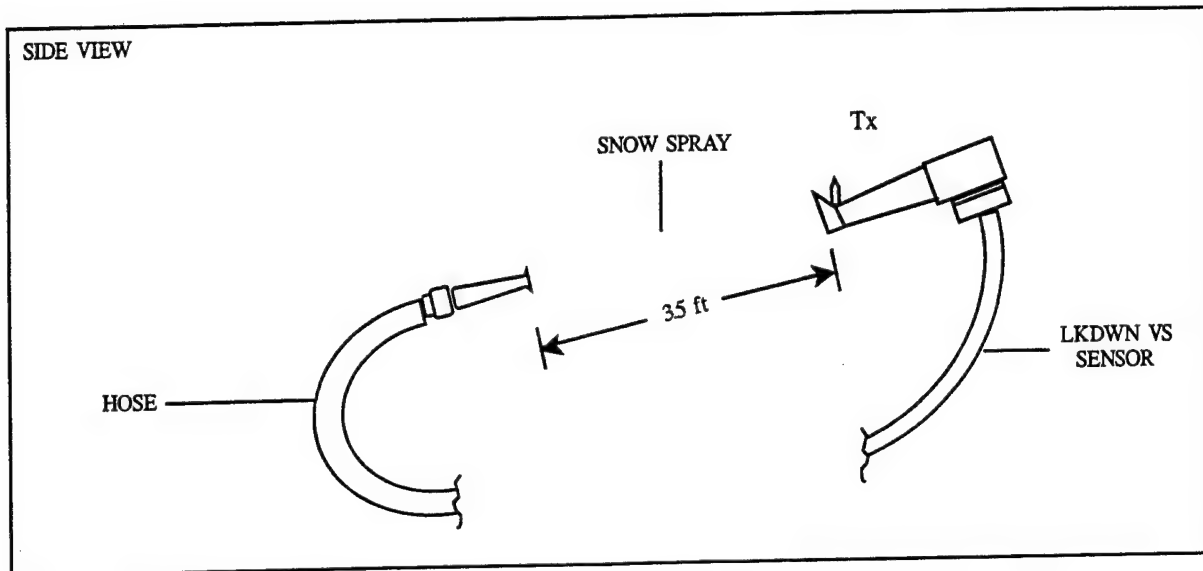
Figure 8. Upward Blowing Snow Test - Location: Navy Chamber

The Upward Blowing Snow test was conducted on the Look-Down VS transmitter on August 5, 1993 in the Navy Chamber. The intent of this test was to simulate a worst case snow event, as well as to determine the limits of the sensors resistance to snow/ice clogging. The saw dust blower with hose was again used for this

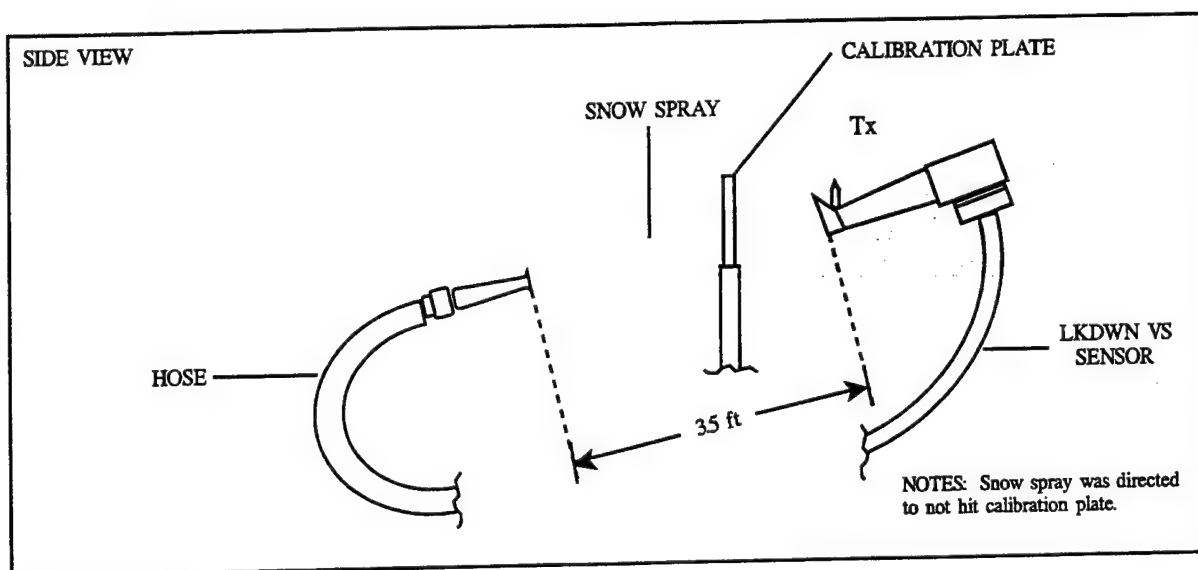
Figure 9. Upward Blowing Snow Test w/ Calibration Plate - Location: Navy Chamber

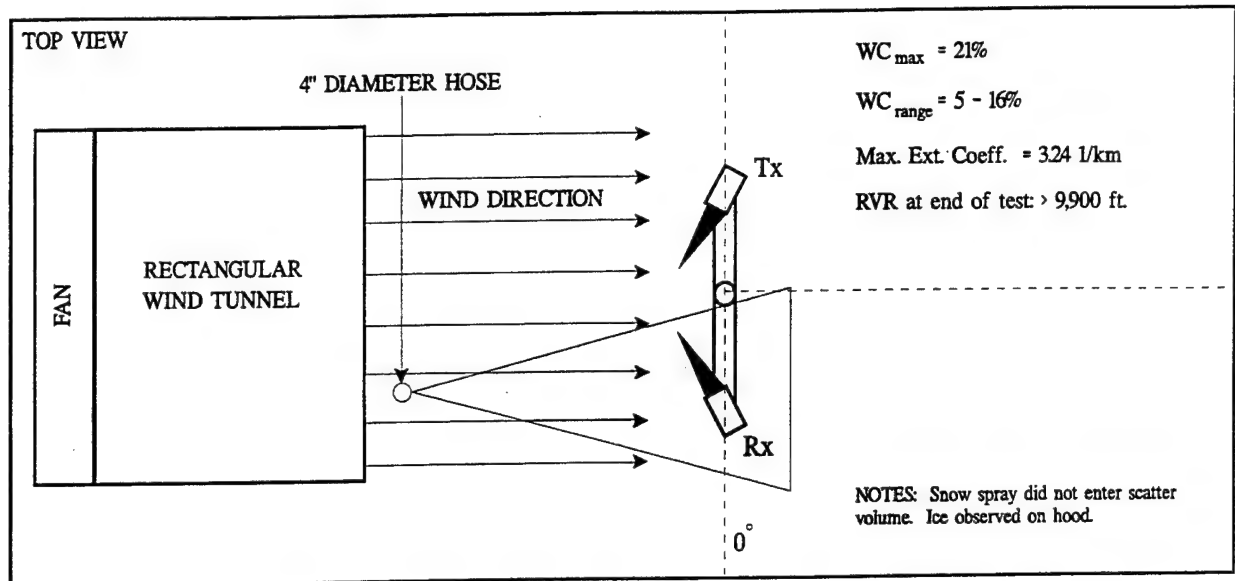
Figure 10. LKDWN VS Blowing Snow Test at 0° (Rx) - Location: ROWPU Chamber

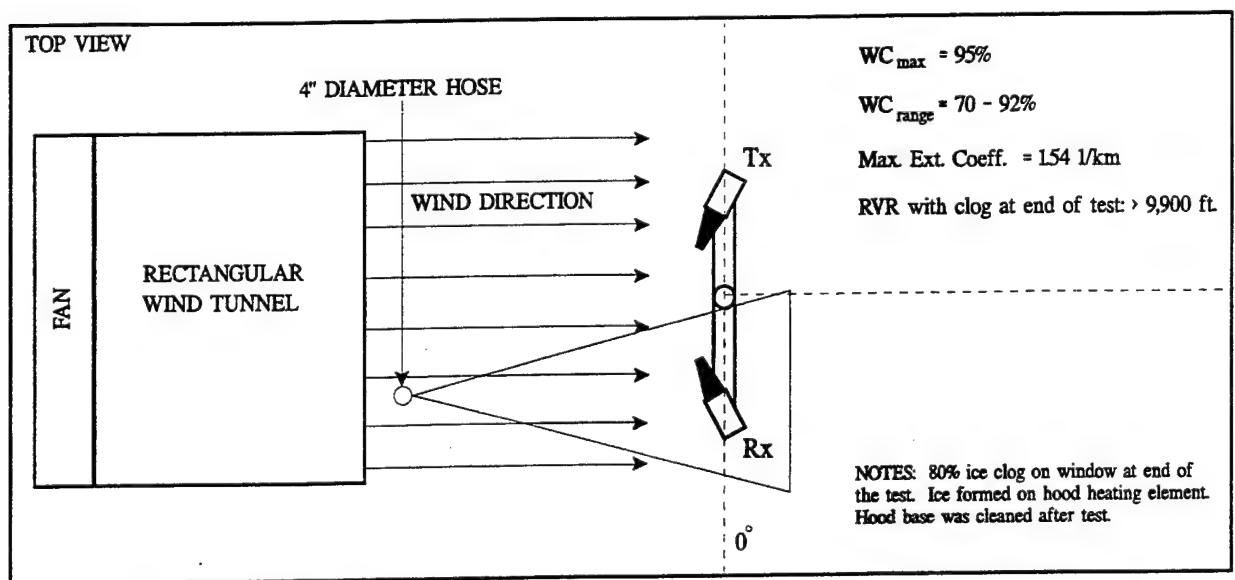
Figure 11. LKOUT VS Blowing Snow Test at 0° (Rx) - Location: ROWPU Chamber

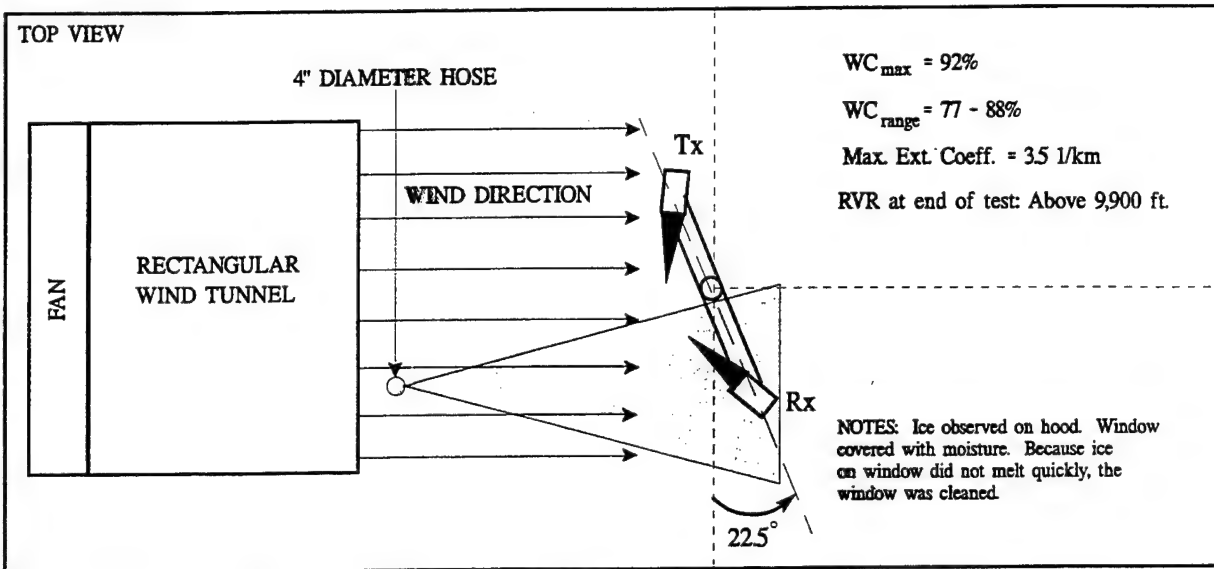
Figure 12. LKDWN VS Blowing Snow Test at 22.5° (Rx) - Location: ROWPU Chamber

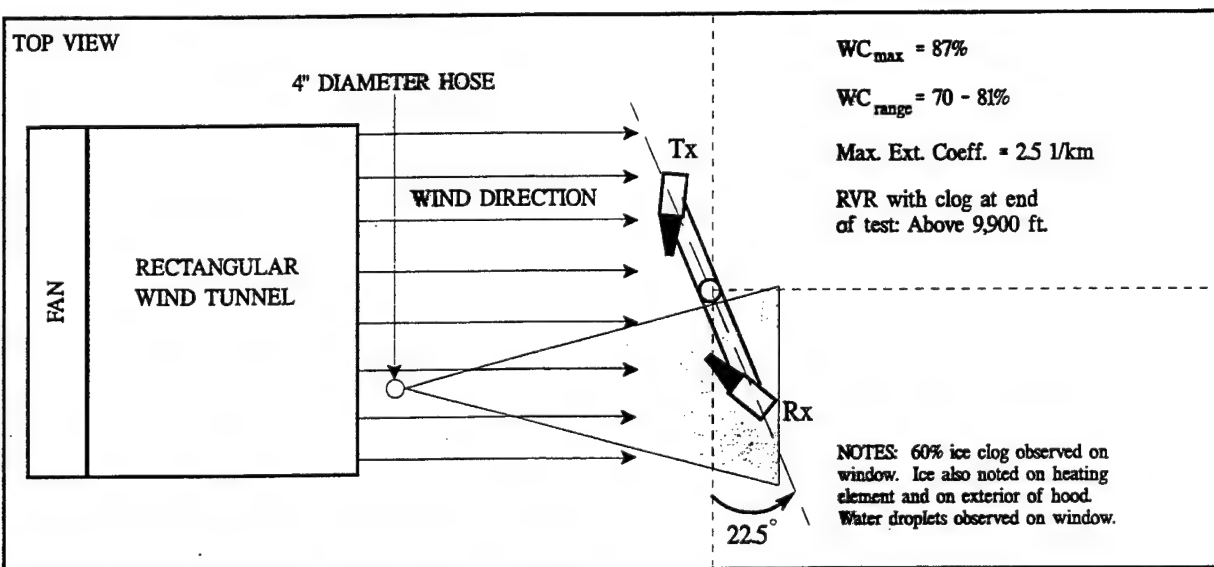
Figure 13. LKOUT VS Blowing Snow Test at 22.5° (Rx) - Location: ROWPU Chamber

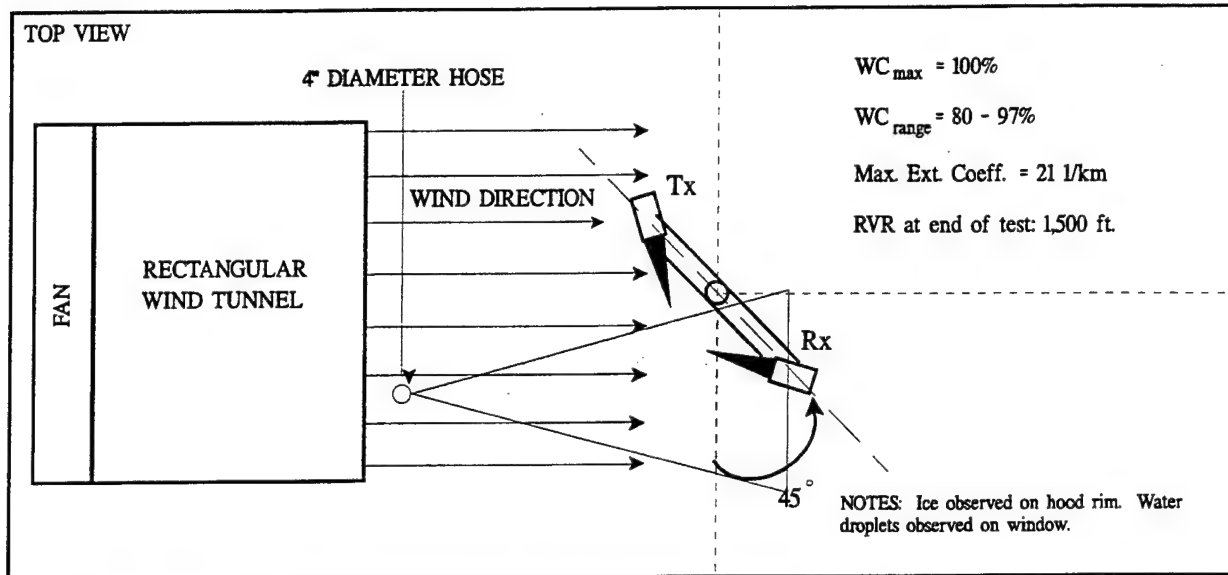
Figure 14. LKDOWN VS Blowing Snow Test at 45°(Rx) - Location: ROWPU Chamber

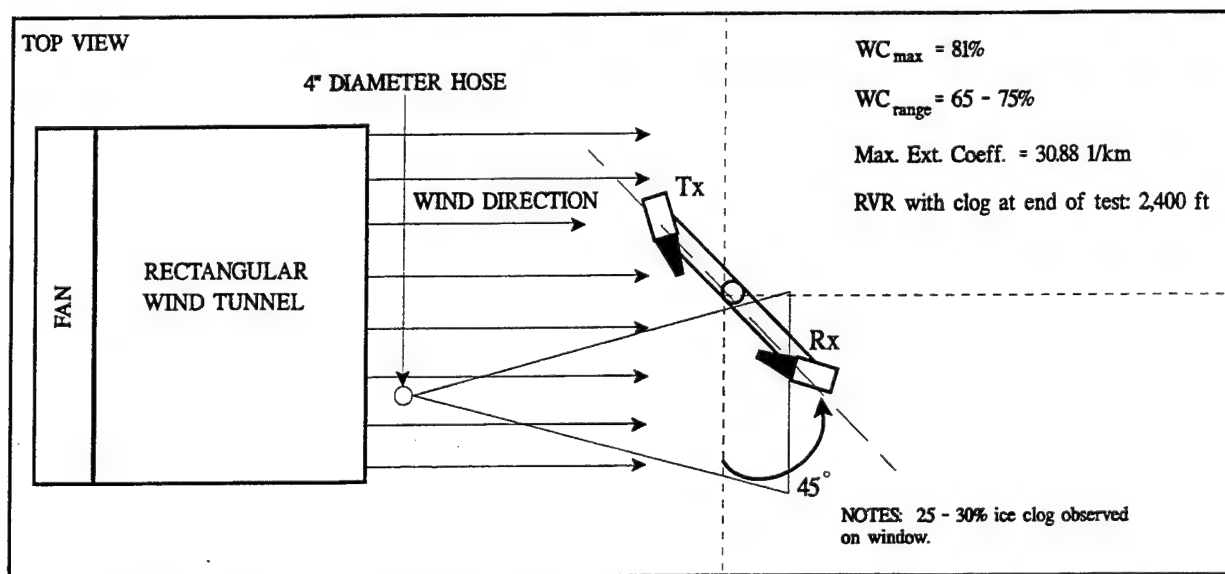
Figure 15. LKOUT VS Blowing Snow Test at 45°(Rx) - Location: ROWPU Chamber

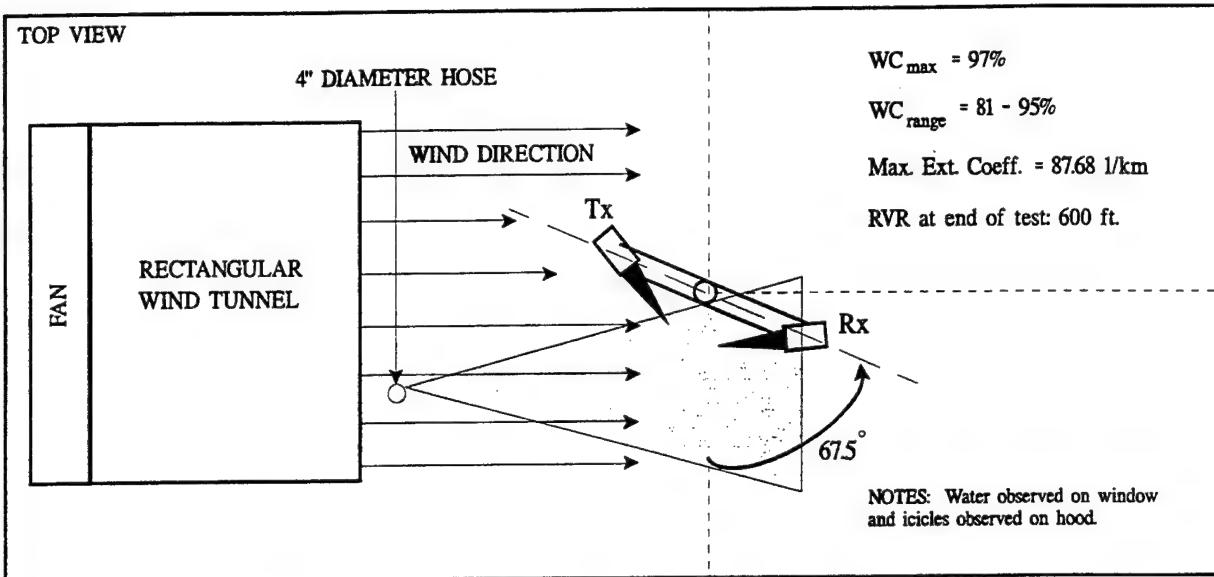
Figure 16. LKDWN VS Blowing Snow Test at 67.5°(Rx) - Location: ROWPU Chamber

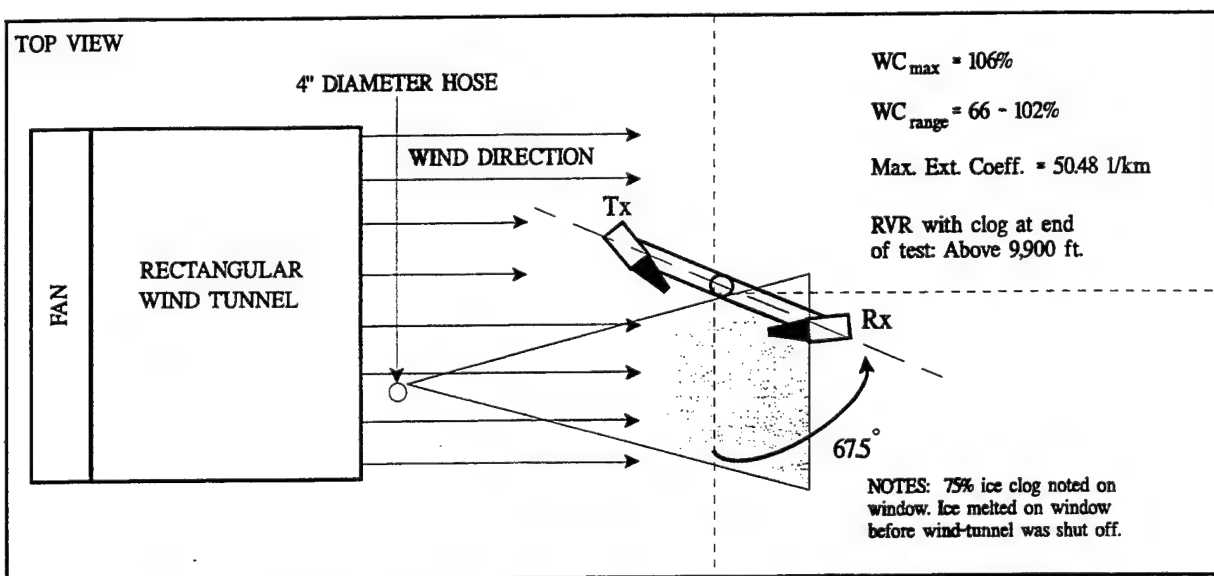
Figure 17. LKOUT VS Blowing Snow Test at 67.5°(Rx) - Location: ROWPU Chamber

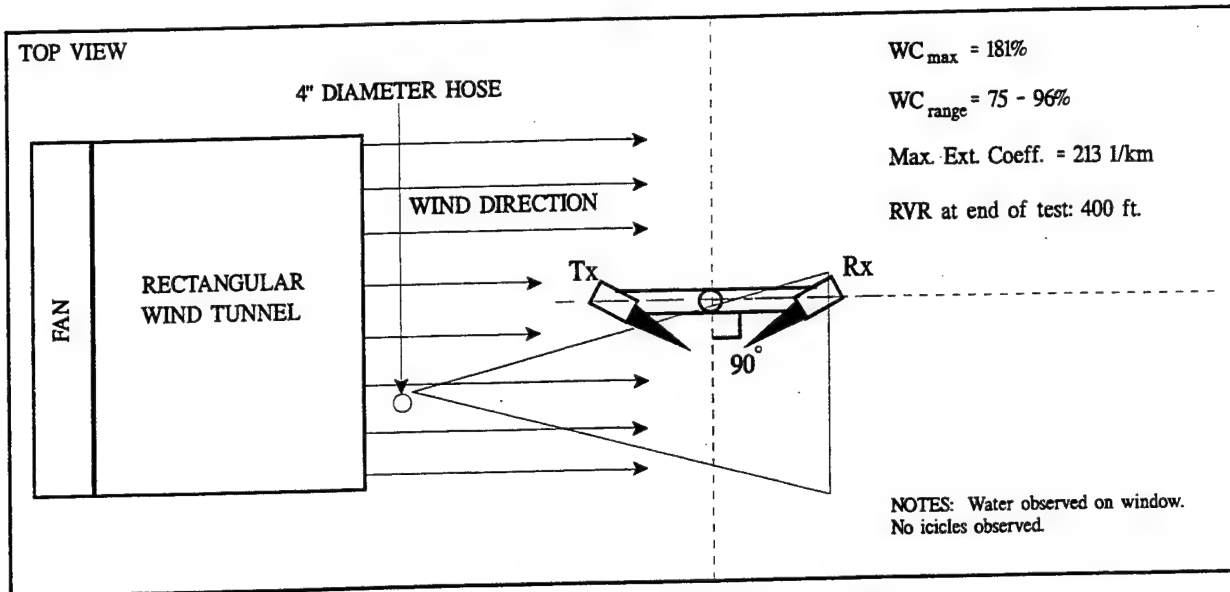
Figure 18. LKDWN VS Blowing Snow Test at 90° (Rx) - Location: ROWPU Chamber

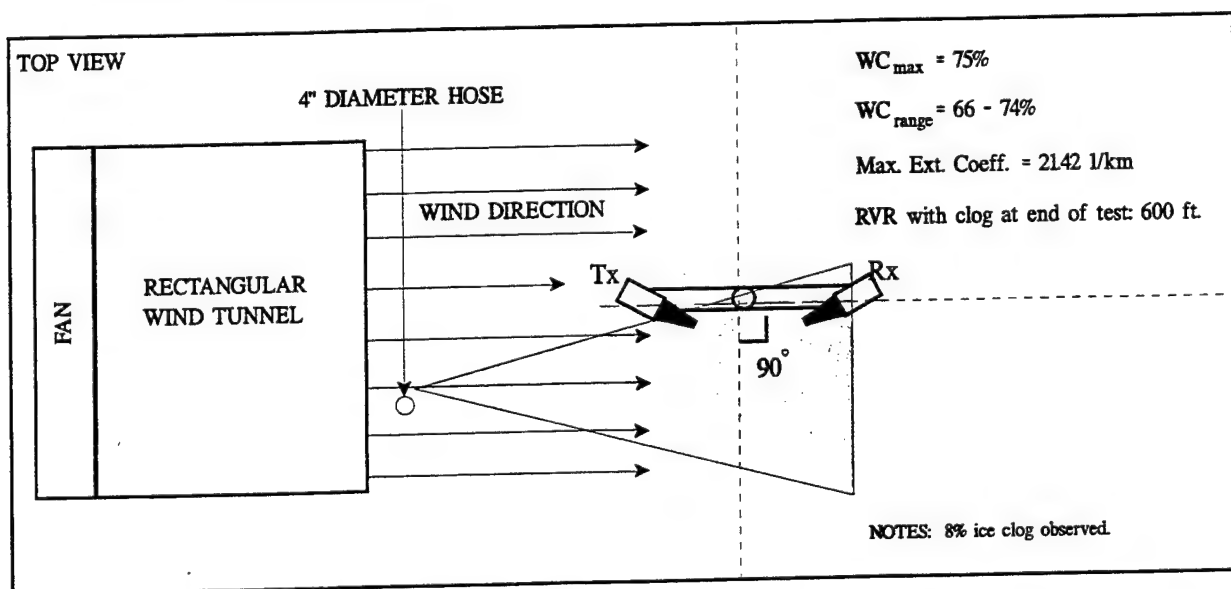
Figure 19. LKOUT VS Blowing Snow Test at 90° (Rx) - Location: ROWPU Chamber

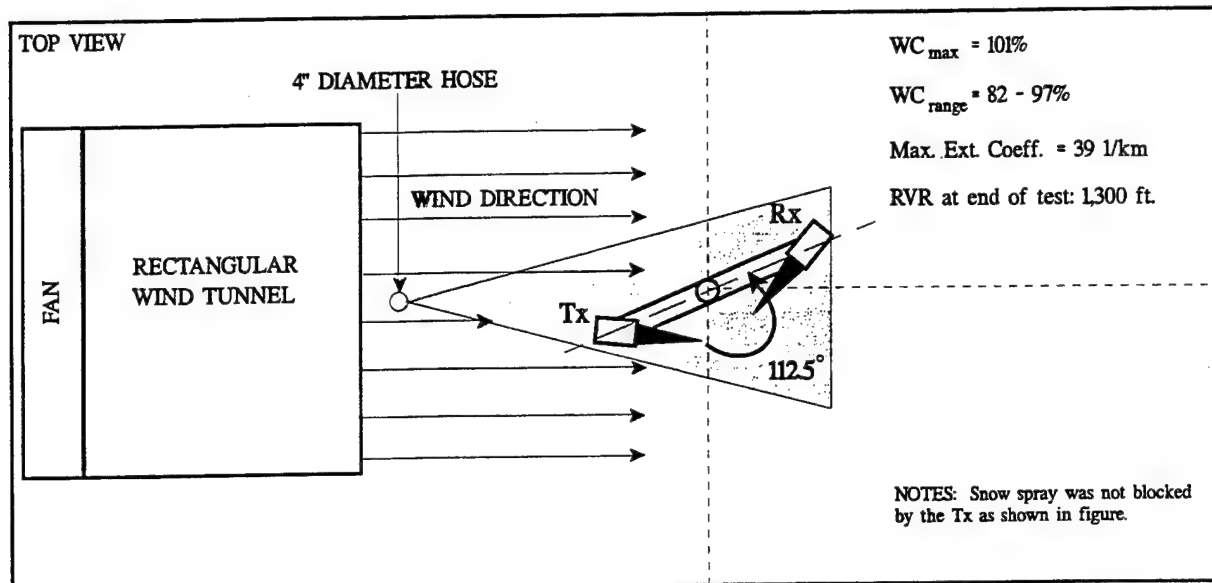
Figure 20. LKDWN VS Blowing Snow Test at 112.5° (Rx) - Location: ROWPU Chamber

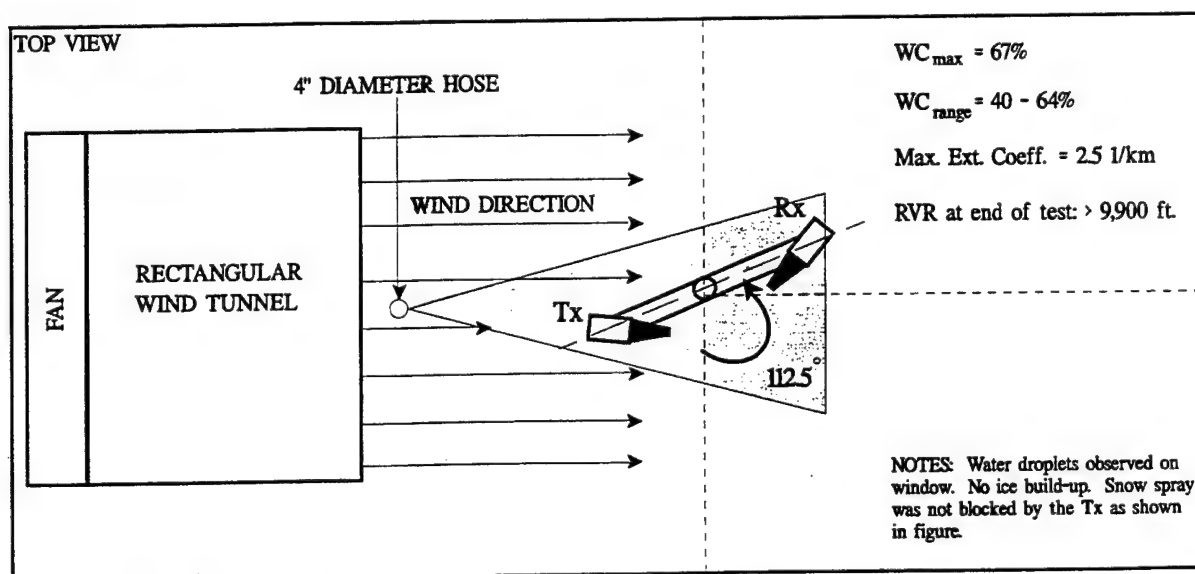
Figure 21. LKOUT VS Blowing Snow Test at 112.5° (Rx) - Location: ROWPU Chamber

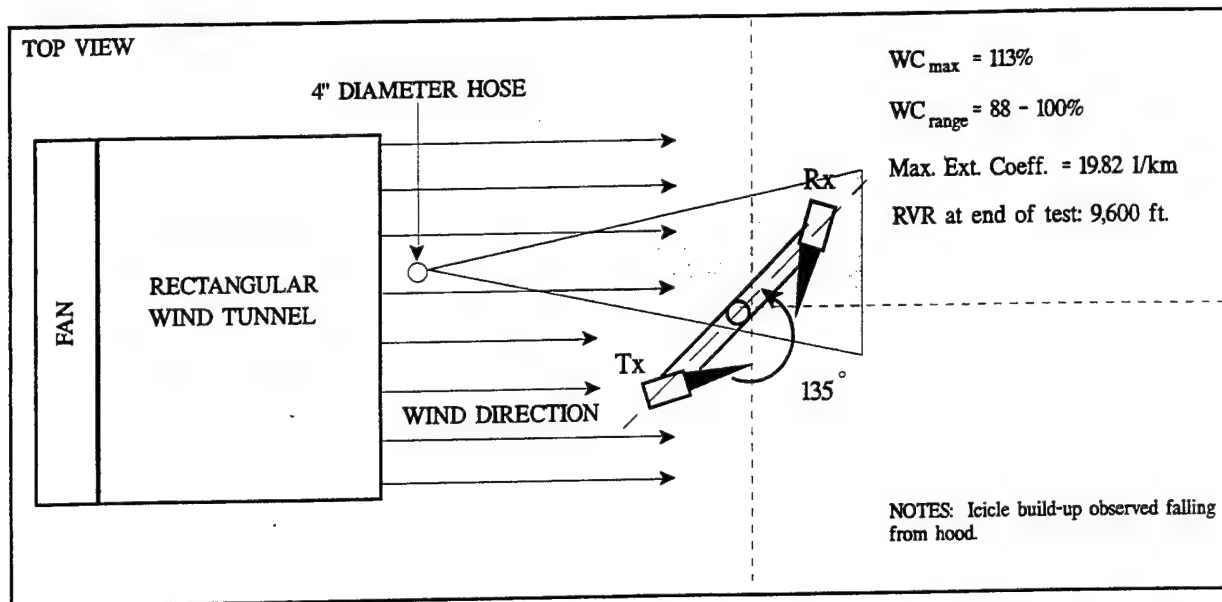
Figure 22. LKDWN VS Blowing Snow Test at 135° (Rx) - Location: ROWPU Chamber

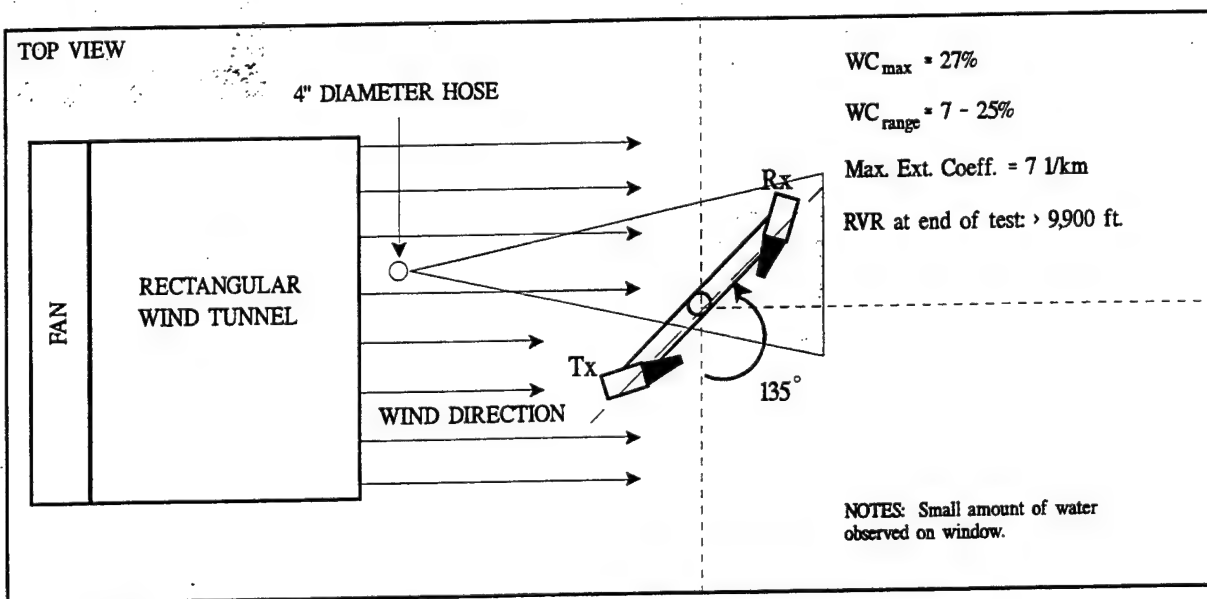
Figure 23. LKOUT VS Blowing Snow Test at 135° (Rx) - Location: ROWPU Chamber

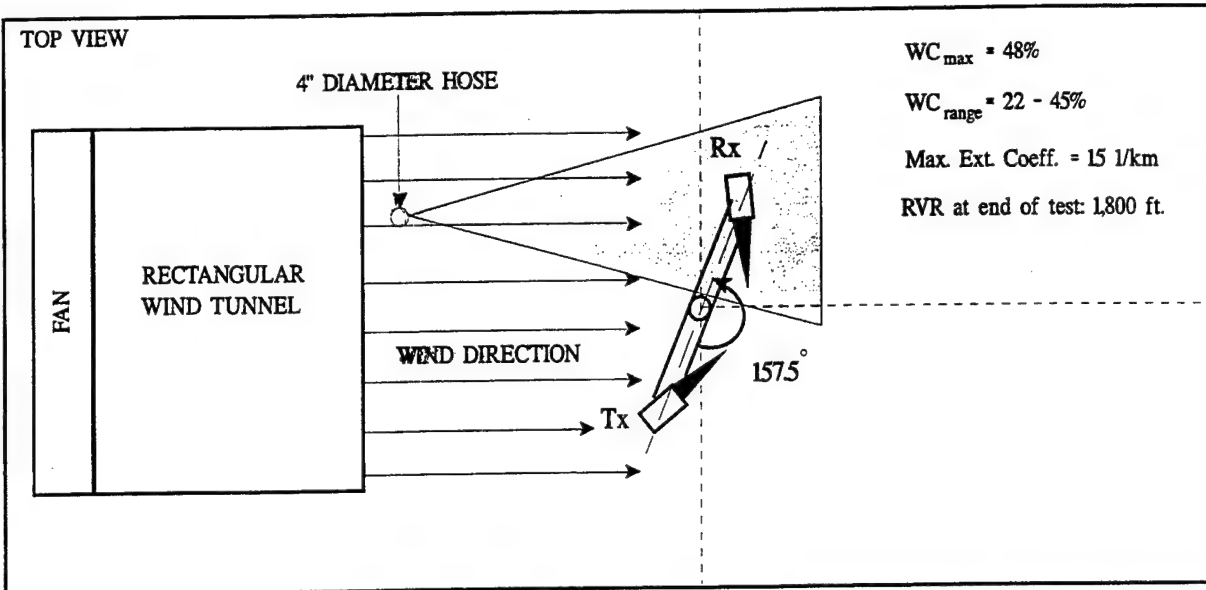
Figure 24. LKDWN VS Blowing Snow Test at 157.5°(Rx) - Location: ROWPU Chamber

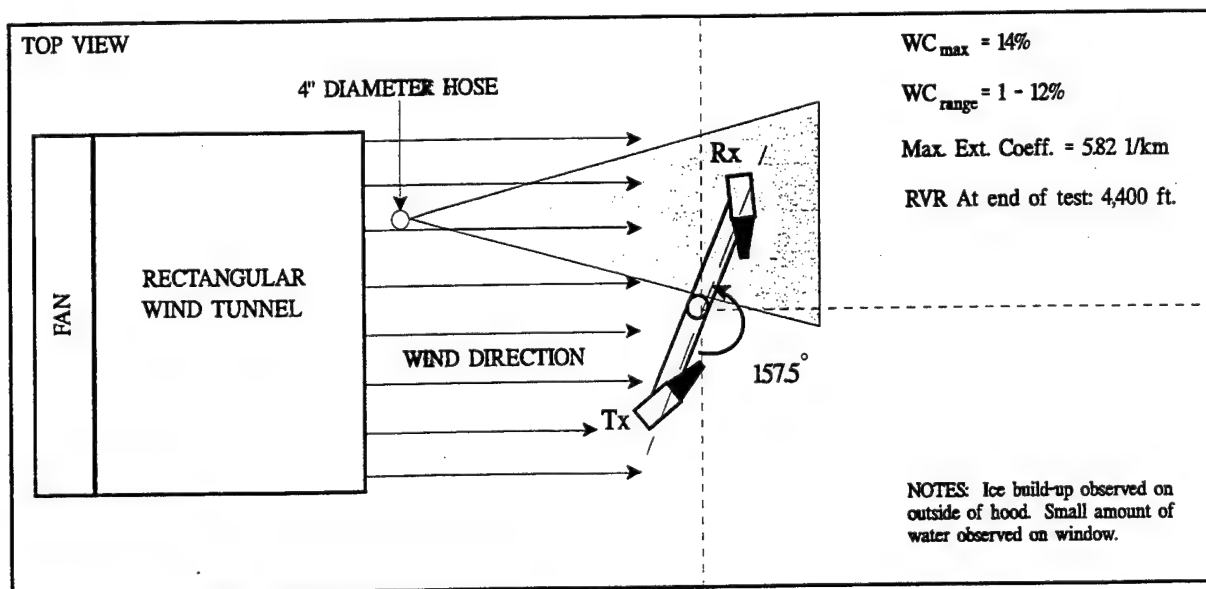
Figure 25. LKOUT VS Blowing Snow Test at 157.5°(Rx) - Location: ROWPU Chamber

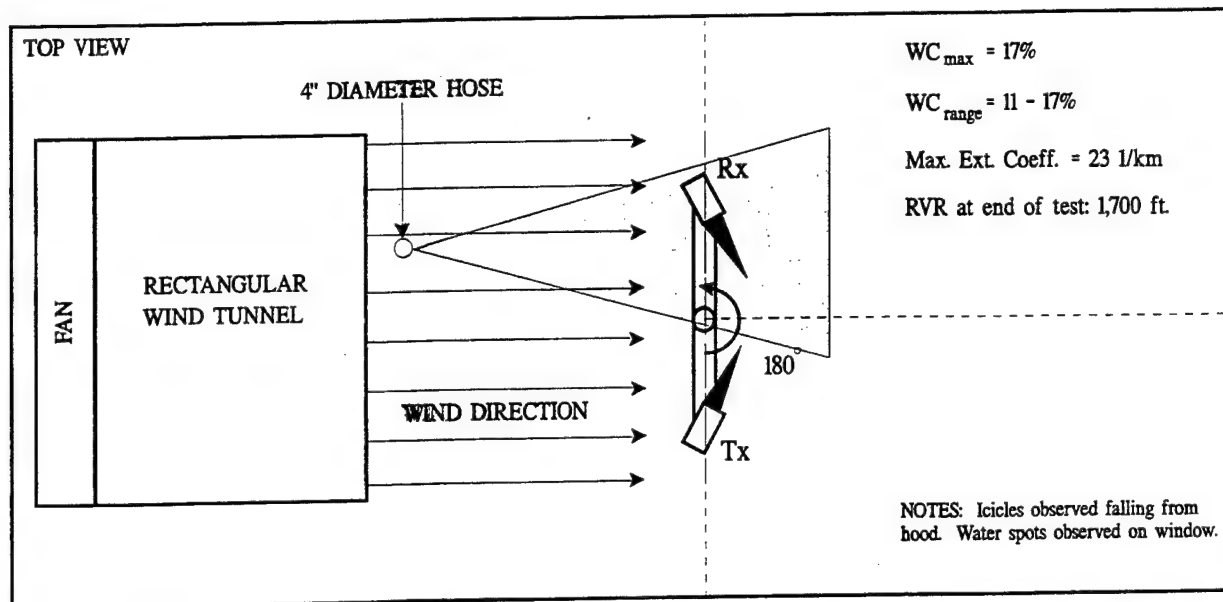
Figure 26. LKDOWN VS Blowing Snow Test at 180° (Rx) - Location: ROWPU Chamber

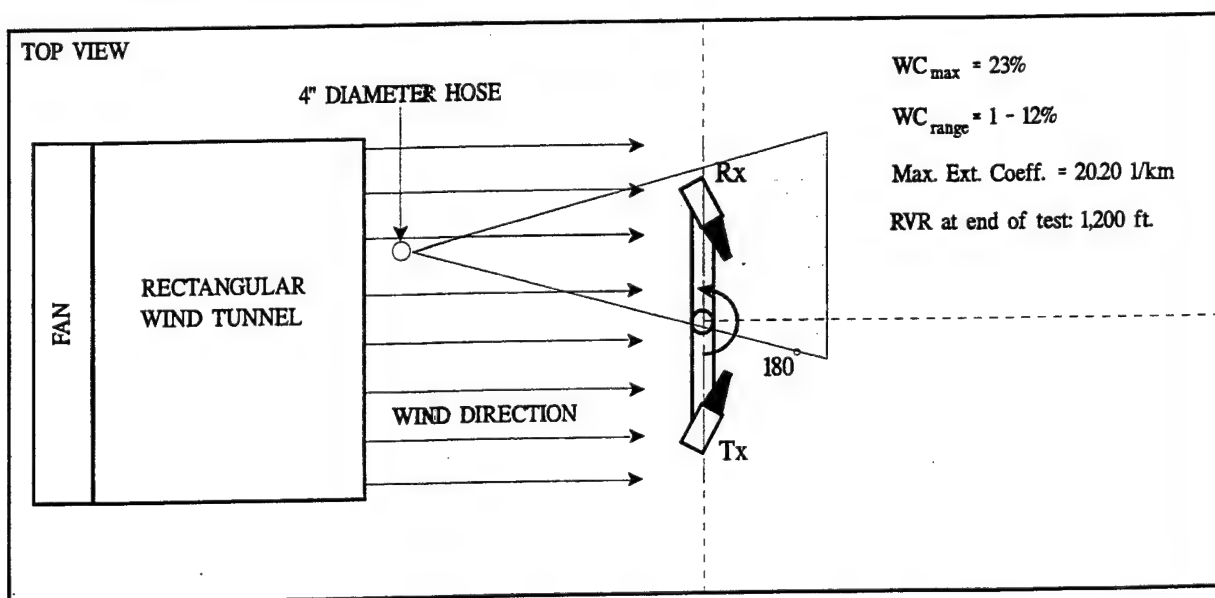
Figure 27. LKOUT VS Blowing Snow Test at 180° (Rx) - Location: ROWPU Chamber
